**Evaluación y riesgo sísmico de edificaciones de albañilería confinada en la  
ciudad de Eten – Chiclayo – Perú, 2023**

**TRABAJO DE INVESTIGACIÓN PARA OPTAR EL GRADO ACADÉMICO DE  
BACHILLER EN INGENIERÍA CIVIL AMBIENTAL**

The results of soil tests, visual inspections and mathematical models of 14 masonry houses belonging to a state program called "Techo Propio" (Own Roof), located in the city of Eten, Chiclayo province, Peru, are presented. In order to evaluate the damage to which the houses are subjected, the probable causes of their predominant pathologies are determined.

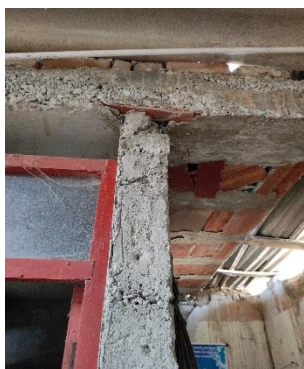
According to the American Concrete Institute (ACI), it defines a crawl space as an empty space that is present in the concrete, either due to the construction process, inadequate mix design or poor gradation of materials [2] (Figure 2).

Figure 2. Concrete Spalling – House N°12

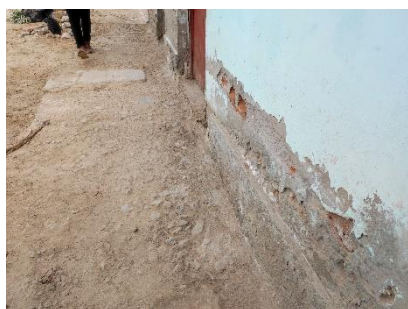
This pathology is one of the most common in dwellings, due to the area in which they are located, or the humidity that concentrates in them. The ACI explains it as an accumulation of whitish salts, which originates in the superficial part of the constructive element (Figure 3), either in walls or concrete structures, and precipitates by the action of evaporation [2].

Figure 3. Efflorescence in walls – House N° 06

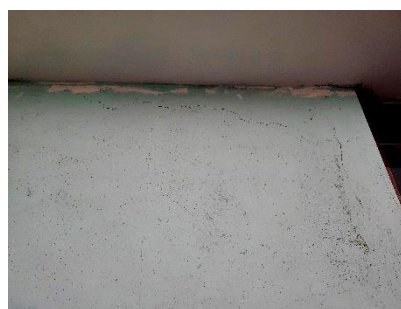
They are elongated openings, with a separation of up to 1 mm, which only affect the superficial part of the construction element (Figure 3). Their presence is caused by temperature changes, inefficient load distribution, soil movements and tension between its reinforcements [3].

Figure 4. Fissures in walls - House N°10

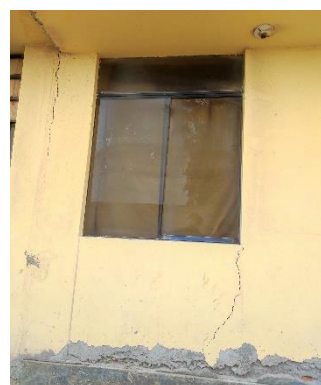
These are openings with a separation greater than 1 mm (Figure 4). Compared to the crack, this affects the structure in its entire width and can affect the seismic response capacity of any construction element [3].

Figure 5. Cracks in walls - House N° 06
