**Evaluación y riesgo sísmico de edificaciones de albañilería confinada en la  
ciudad de Eten – Chiclayo – Perú, 2023**

**TRABAJO DE INVESTIGACIÓN PARA OPTAR EL GRADO ACADÉMICO DE  
BACHILLER EN INGENIERÍA CIVIL AMBIENTAL**

The results of soil tests, visual inspections and mathematical models of 14 masonry houses belonging to a state program called "Techo Propio" (Own Roof), located in the city of Eten, Chiclayo province, Peru, are presented. In order to evaluate the damage to which the houses are subjected, the probable causes of their predominant pathologies are determined.

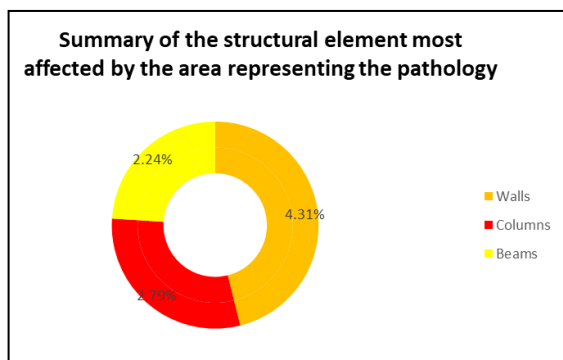
With respect to the structural element most affected by the area presenting the pathology, the following percentages were obtained: 4.31% for walls, 2.79% for columns, and 2.24% for beams (Figure 6)

Figure 6. Summary of the structural element most affected by the area representing the pathology
